Grand Digitizer V2 hardware problems

Version 0.1

Radboud Universiteit Nijmegen

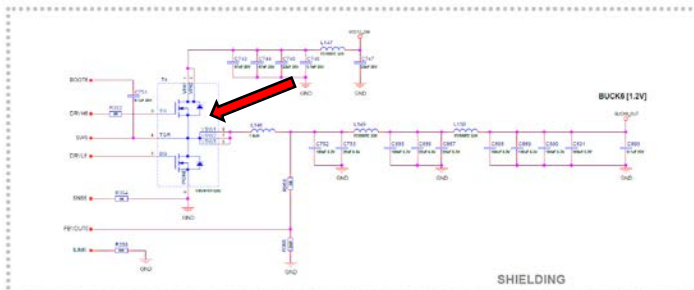
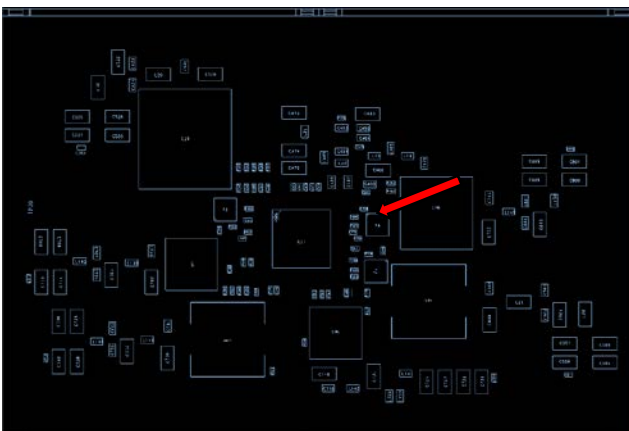
- All power output from the TPS650864 power supply chip is fluctuating; the DC levels are not steady.
- No power present on VCC1V2_PS_DDR and VCC1V2_PL_DDR power lines.
- A short is present between GND and VCC1V2_PS_DDR and VCC1V2_PL_DDR lines.

After isolating the relevant part of the power circuit (BUCK6) it was measurable that the T4: (CSD87331Q3D) FET power block is broken. (TGR and VSW1/2/3 pins were short to GND) Desoldering and measuring the T4 FET power block separately confirmed that it was broken.

- The problem is very unlikely caused by other part of the digitizer because the power FET can withstand much more current than the filter circuit after it. The CSD87331Q3D FET is very vulnerable for ESD, if it is not handled with care in an ESD safe environment it can be damaged. This problem was most probably caused by a faulty FET or mishandling the component.

Replacing it with a new FET solved the problem.
